Case Study

Enhancing customer satisfaction through
product improvement

▶ Oman-based pipe manufacturer

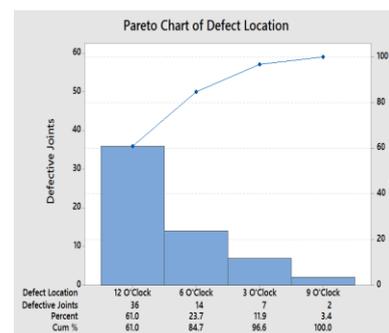
To establish the location of burn marks on the piping, the shore-based project team asked the field team to collect relevant data; the results revealed that 61% of the burn marks were observed at the 12 o'clock position. On further investigation, the shore-based team learnt that this was where the heating blanket overlapped when wrapped round the pipe. Pareto analysis showing the position on the pipe where the burn marks were observed

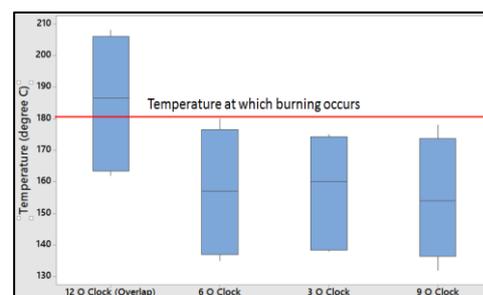
By inspecting the equipment and running some calibration tests, the shore-based project team determined that the equipment was functioning correctly. They also concluded that the problem was being created by the process, and that the most likely root cause was overheating, where the heating blanket

where the heating blanket overlapped when wrapped round the pipe. By measuring the temperature at various positions around the pipe, they could determine with certainty whether 'blanket overlap' was causing excessive heating. At the 12 o'clock position where the heating blanket overlapped itself, the average temperature exceeded 180°C, which was above the specified tolerance and, therefore, a possible cause of burning;

They decided to reduce the temperature at the overlap region by placing insulation in this area. To make improvements to the heating blankets, the client and the heating blanket supplier undertook a trial in which heating blankets were fitted with external temperature regulators. In addition, the heating segment of the heating blanket was reduced at the location of the overlap.

Before selecting their final improvement strategy, the team tested their various improvement ideas. Identifying the need for new heating blankets with modified heating elements (especially around the overlap areas), they chose an external temperature controller in preference to internal thermocouples, since the external temperature controller offered better control over the temperature range.
